# PID KILLER

## SUCCESS STORIES

Israel

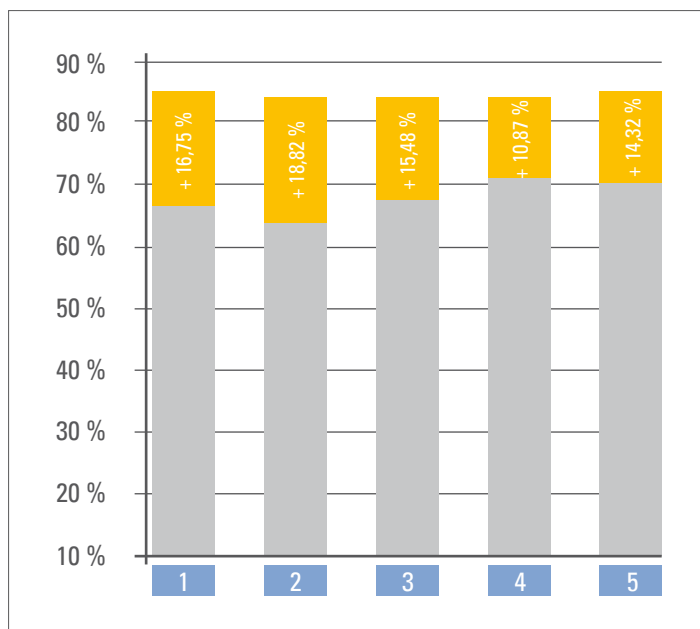
### Improving module power output by 18,82%

The graphic demonstrates the recovery process based on the PR-performance:

String / String package	Before	After
1	67,36 %	84,11 %
2	64,36 %	83,18 %
3	67,68%	83,16 %
4	72,43 %	83,30 %
5	70,18 %	84,50 %

ring system, we could easily supervised the individual parameters and the operation of the device. In this test installation, is in addition to the enormous recovery rate, positive to watch, that the individual string packages returned within the test period to the same proficiency of performance (PR), although they were different affected with PID, too test launch.
